RESEARCH MEMORANDUM

INVESTIGATION OF MECHANICAL FASTENINGS FOR SOLID
TURBINE BLADES MADE FROM DUCTILE MATERIALS

By André J. Meyer, Jr., Albert Kaufman, and W. C. Caywood

NACA RM E54E21

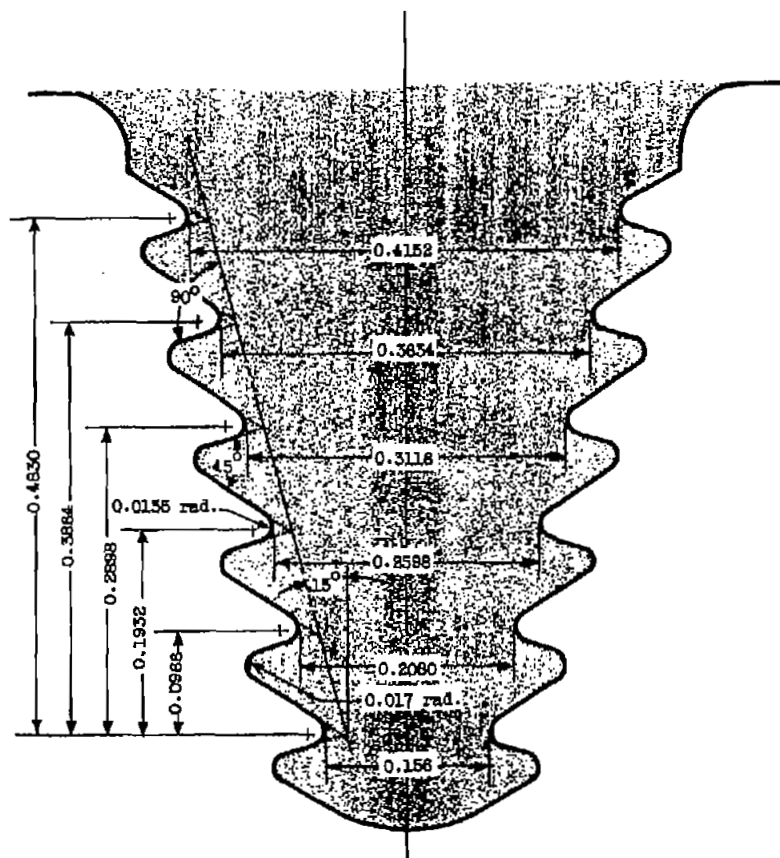
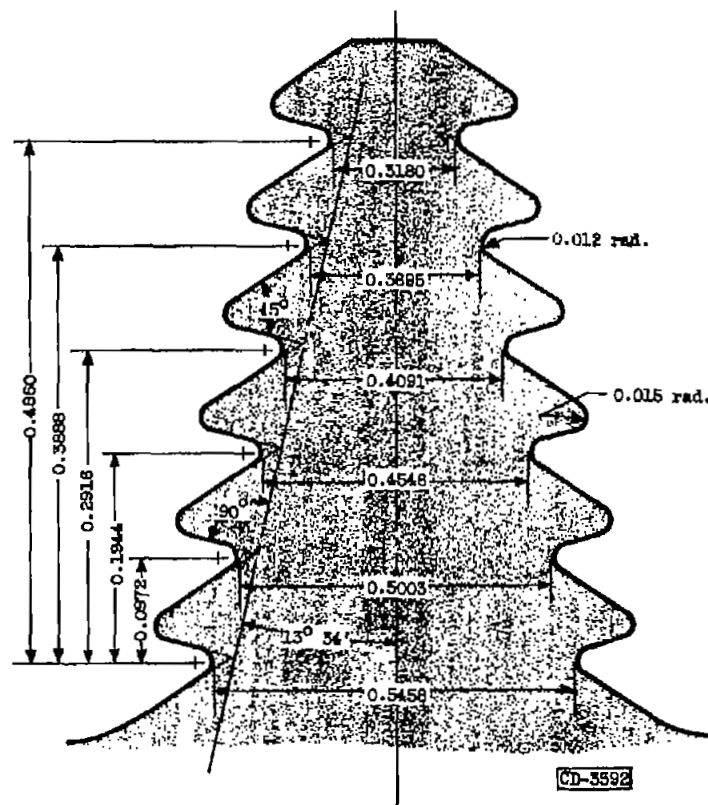
(a) Blade root A.

(b) Turbine rotor segment A.

Figure 2. - Dimensions of three fir-tree roots tested (inches).

Three specific root designs were tested, one with six pairs of small serrations, one with six pairs of larger serrations, and one with only three pairs of larger serrations. These profiles are not hypothetical designs but have been mass-produced and have experienced thousands of hours of service operation. They were chosen to explore the important criteria for designing serrated roots, to observe the modes of failure, and to investigate the factors affecting the root strengths. The operating loads and stresses to which the root strengths are compared are based on the airfoil weight, rotor diameters, and rated speed of the particular engine for which the root was designed.

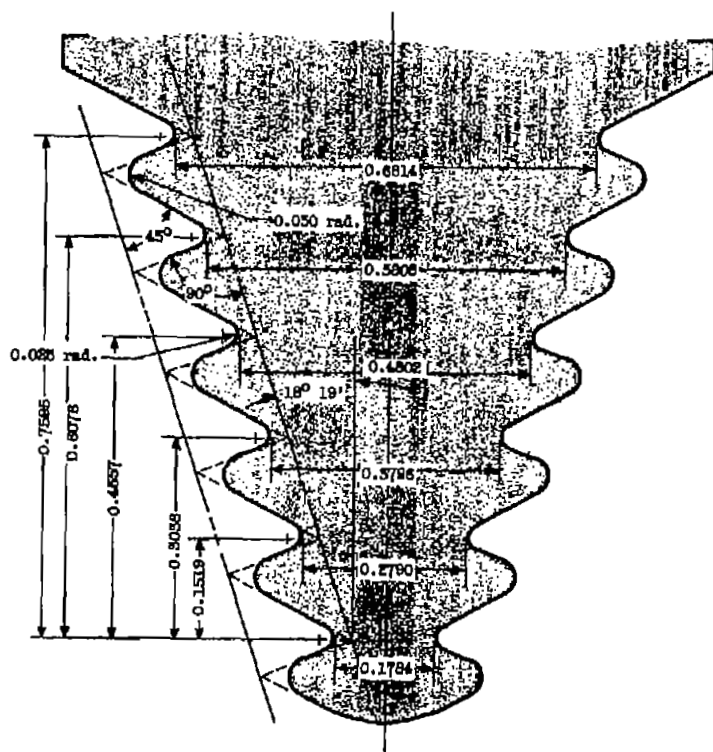
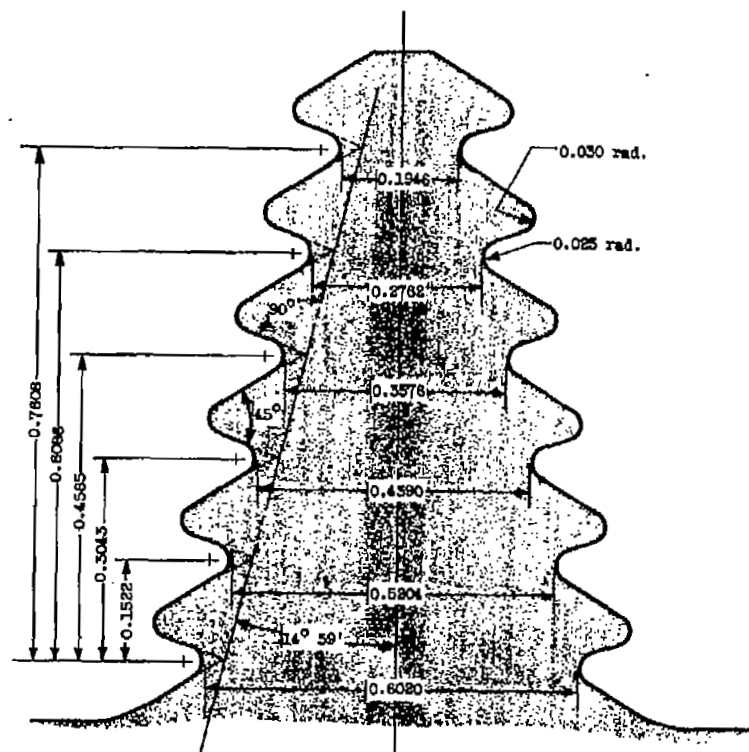
(e) Blade root C.

(f) Turbine rotor segment C.

Figure 2. - Concluded. Dimensions of three fir-tree roots tested (inches).

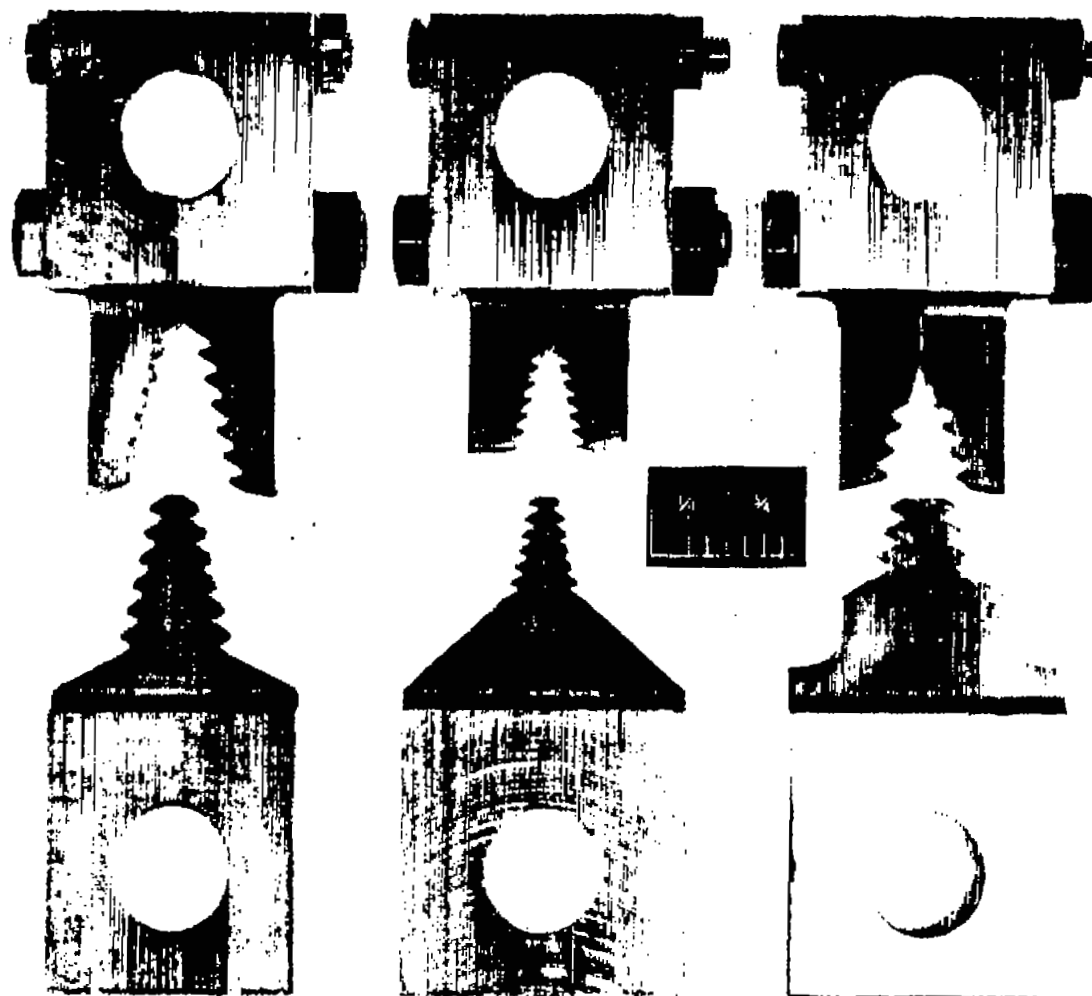
Figure 4. - Tensile specimens used to simulate turbine rotor segment between adjacent blades.

Another style specimen, shown in figure 4, was used to evaluate the strength of the turbine wheel segments between adjacent blades. The blade component was again cast from Stellite 21 but was made in two pieces to facilitate grinding of serrations. The parts representing wheel segments were actually machined from production turbine rotors. The same restraining clamps used with the other specimen were again used here.

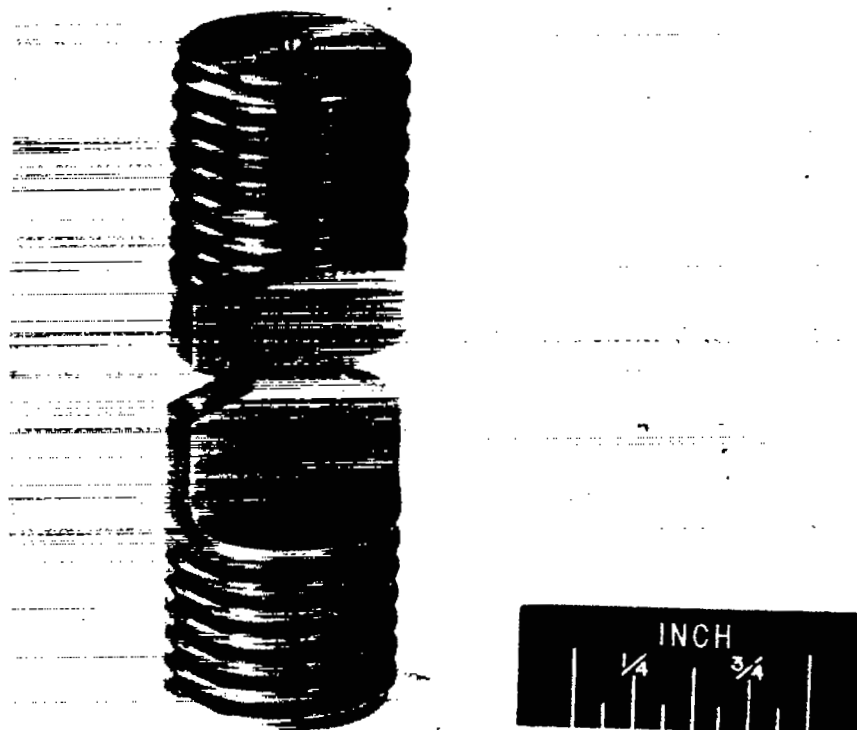
Figure 5. - Notched tensile specimen for determining material properties.

In order to determine the mechanical properties of turbine blade and rotor materials, the notched and unnotched tensile specimens and the 1/8-inch-diameter shear-pin specimen shown in figures 5 to 7 were utilized. The testing was conducted in both screw and lever stress-rupture machines. Chromel-alumel thermocouples were placed in the locations where failure was expected.

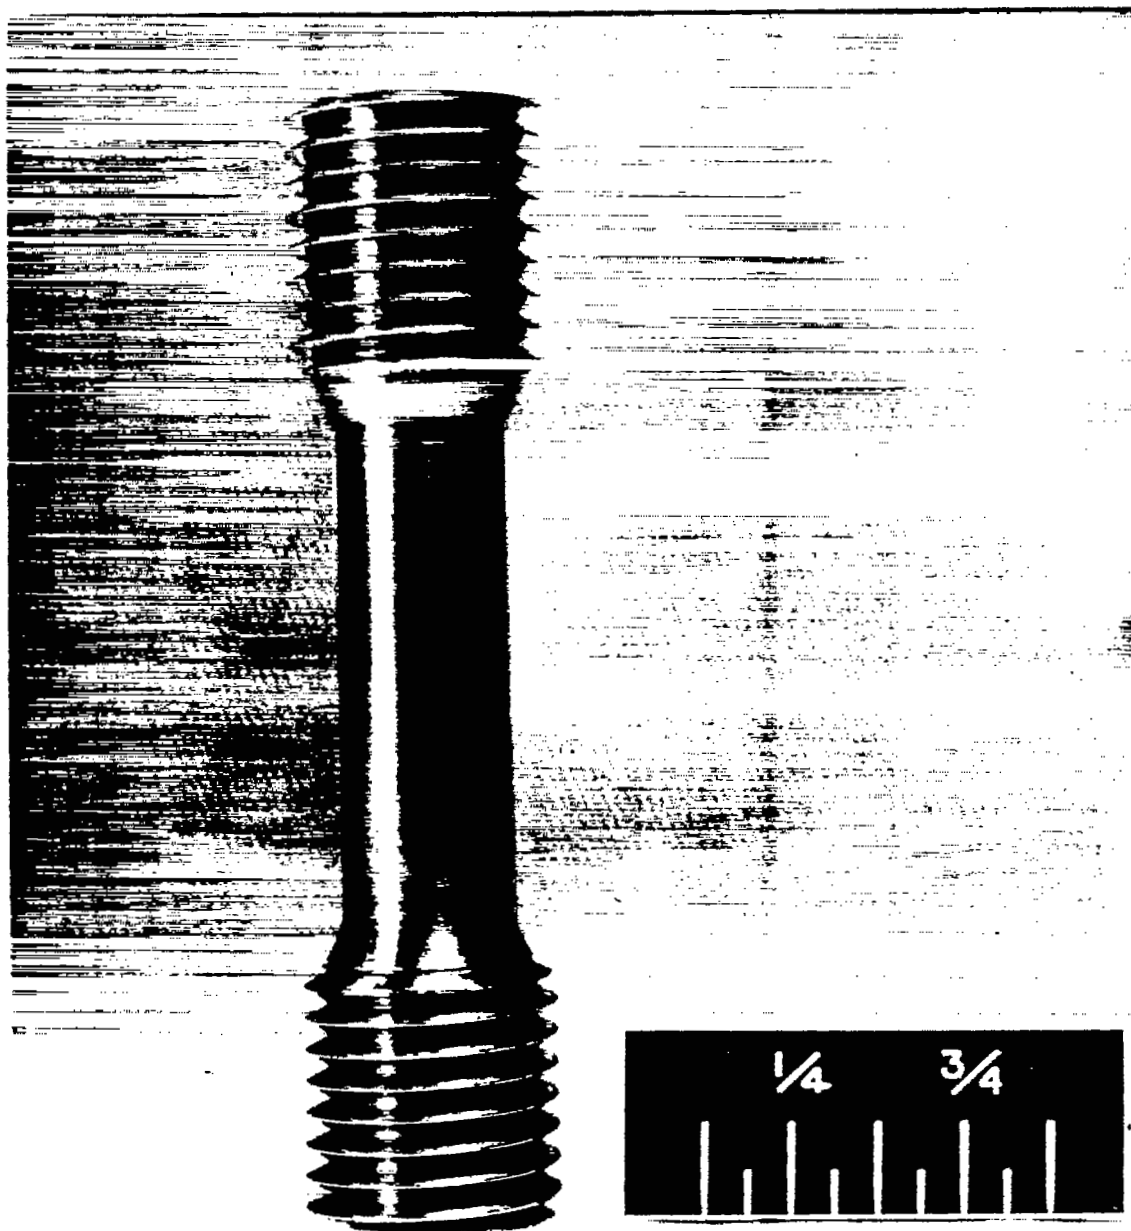
Figure 6. - Unnotched test bar for determining tensile properties of rotor material.

The mechanism of failure changed according to temperature and root proportions, as illustrated in figure 10. With blade A the failure was one of tension below 1200° F and shifted to a shear failure above 1200° F. Blade B failed in shear over the whole temperature range, with a single tensile failure occurring at room temperature. In order to explain the shift in failure mechanism, short-time test data for both mechanisms of failure were plotted against temperature for the materials involved (fig. 11). Tensile data were taken from the literature (refs. 2 to 4) and confirmed by NACA data from the unnotched tensile bar (fig. 6). Shear data were obtained by shearing 1/8-inch-diameter pins (fig. 7).

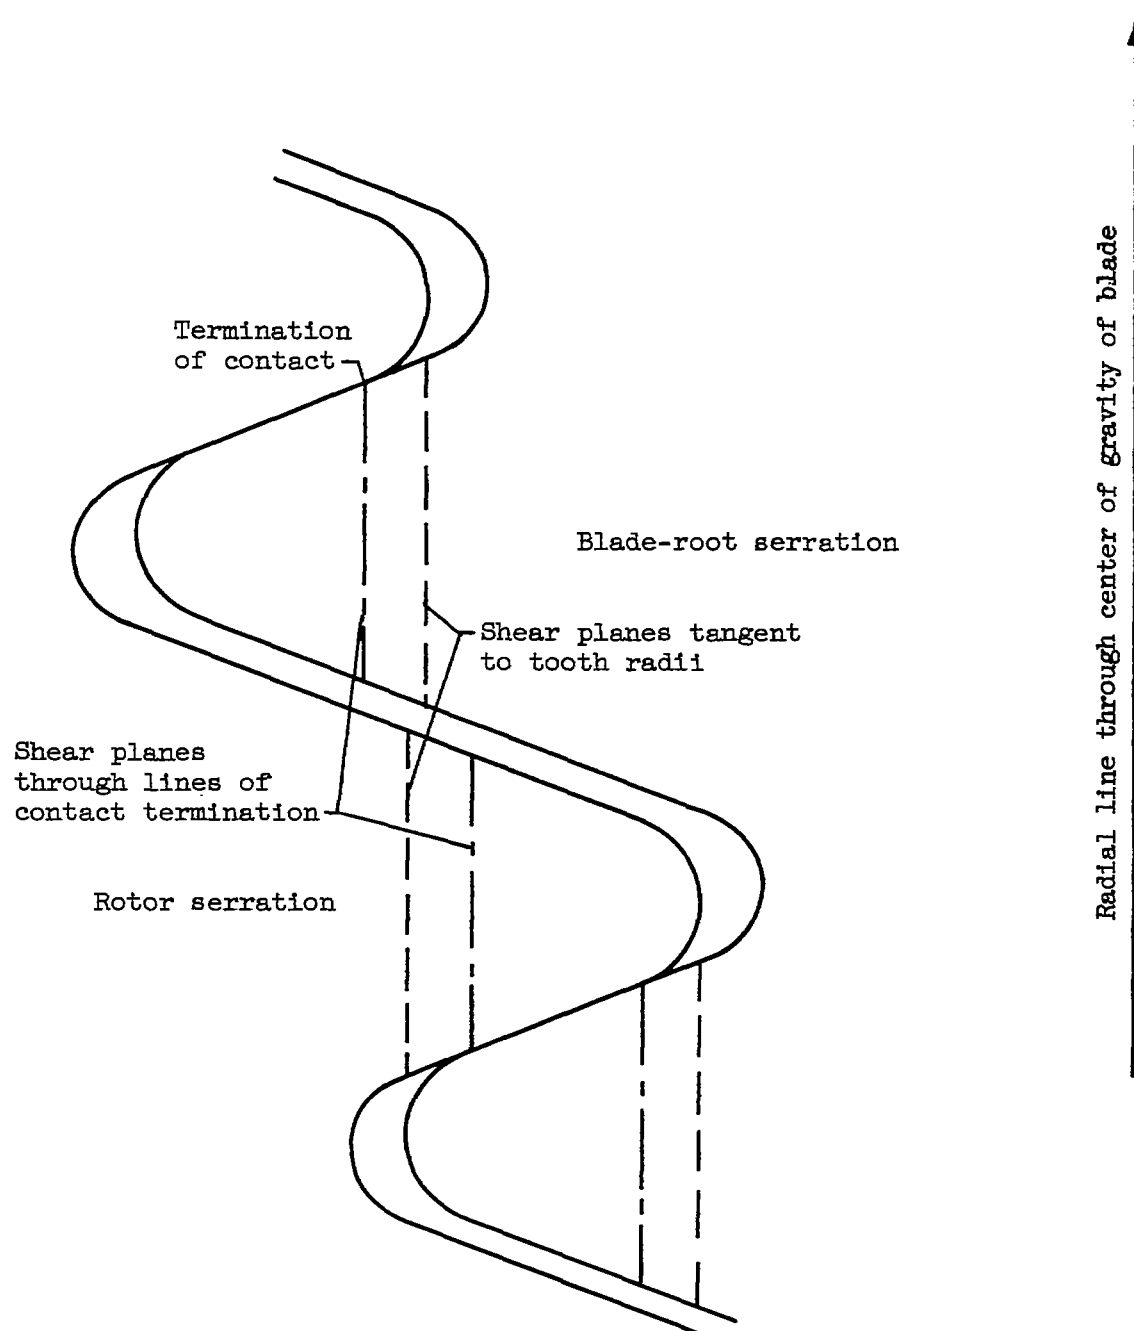
Figure 8. - Shear-plane locations used in computing shear stresses.

In order to determine the stresses resulting from tests of serrated specimens, some assumption must be made concerning the shear areas of the teeth. In determining the shear stresses, the question arises as to what cross-sectional area is actually subjected to the shearing action. From figure 8 it is apparent that two different extremes of the shear plane could be considered, as indicated by the two types of dashed lines. Both planes are parallel to the radial line passing through the center of gravity of the blade, which for the roots investigated was approximately coincident with the root center lines. One plane, however, is tangent to the apex radius of the serration tooth applying the load. This shear plane would probably be in effect just before ultimate failure occurred. The other plane contains the line where contact is terminated between the loaded and the loading tooth and should correspond to the shear plane acting when load is first applied before any deformation has taken place. For all computations of shear stress, the mean of these two shear areas was used, and it was further assumed that the shear stresses in all teeth were equal. The effective tensile area used in determining the tensile stresses was the minimum area across the serration fillets.

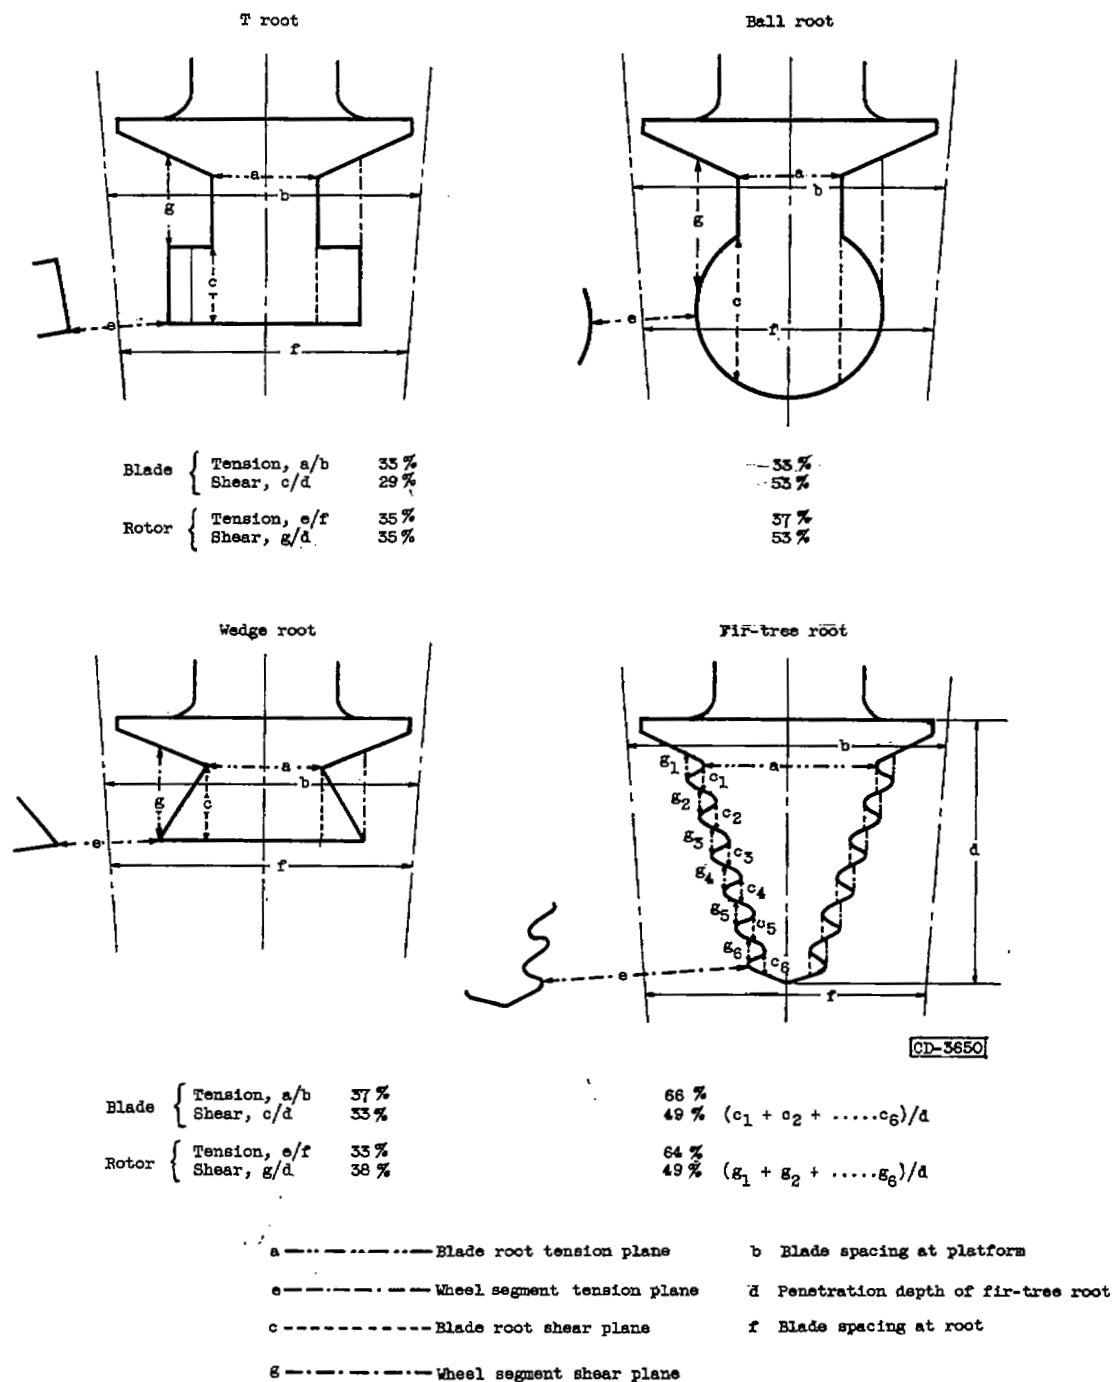
Figure 9. - Basic root configurations.

Many root forms have been proposed for fastening turbine blades to the rotor. In figure 9 are illustrated a few of the more important basic configurations, of which variations have been introduced in recent years. The percentages listed under each root type indicate the amount of the maximum available tensile or shear area that was actually utilized by each type. A 100-percent tensile area of the blade root, for example, would mean that the root neck of the blade touches those of adjacent blades and no space is left for the wheel segment. Thus, 100-percent tensile area is possible only if the blade is integral with the wheel or welded to it. The percentage shear area is obtained by dividing the actual area of the blade or the wheel segment supporting the centrifugal load in shear by the rim thickness multiplied by twice (double shear) the radial penetration depth for the fir-tree root d. The depth of fir-tree root was chosen so as to obtain a common basis for comparison. The actual numerical values, of course, can be varied considerably by adjusting the proportions of each design. Considerable discretion was involved in deciding the proportions to be used; all factors must be taken into account, including bearing loads, wheel strength, and so forth. The percentages calculated are reasonably representative of the highest values obtainable for practical configurations. The blade tensile area generally can be increased at the expense of either the shear area or the tensile area of the wheel, and vice versa.

By comparing percentage values it can be observed that the ball root has the highest shear values, but low tensile values. In fact, the fir-tree configuration has tensile values almost twice those of the other roots; and it is, therefore, appreciably more efficient than all the other forms. It is for this reason that only the fir-tree-root form has been used extensively for aircraft gas turbines, although many other roots have been tested.

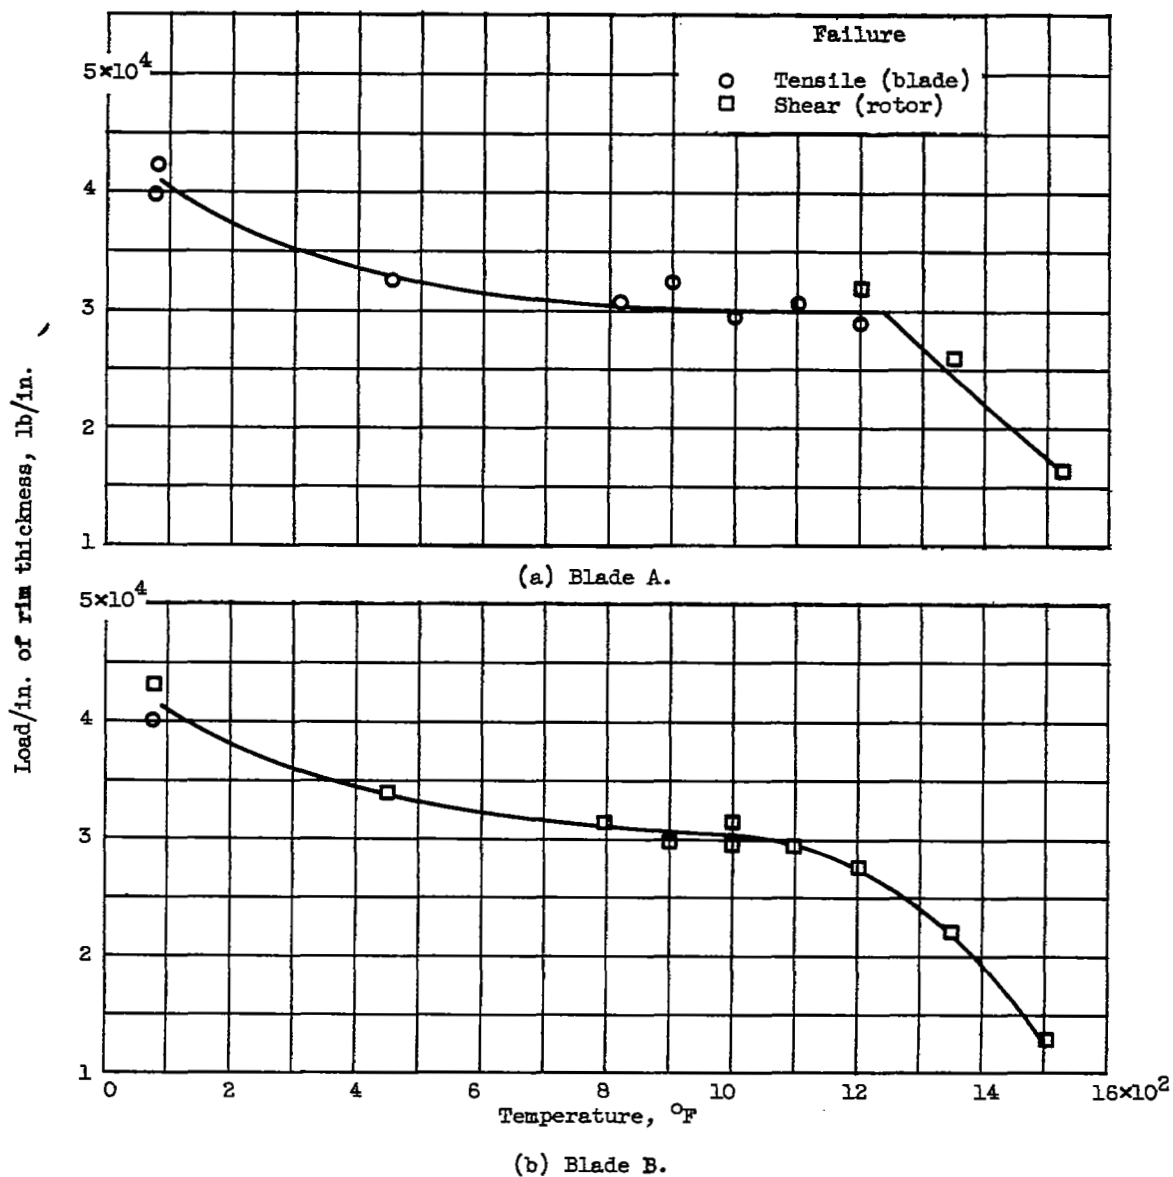
Figure 10. - Short-time tensile-test results at various temperatures for blade A and B specimens.

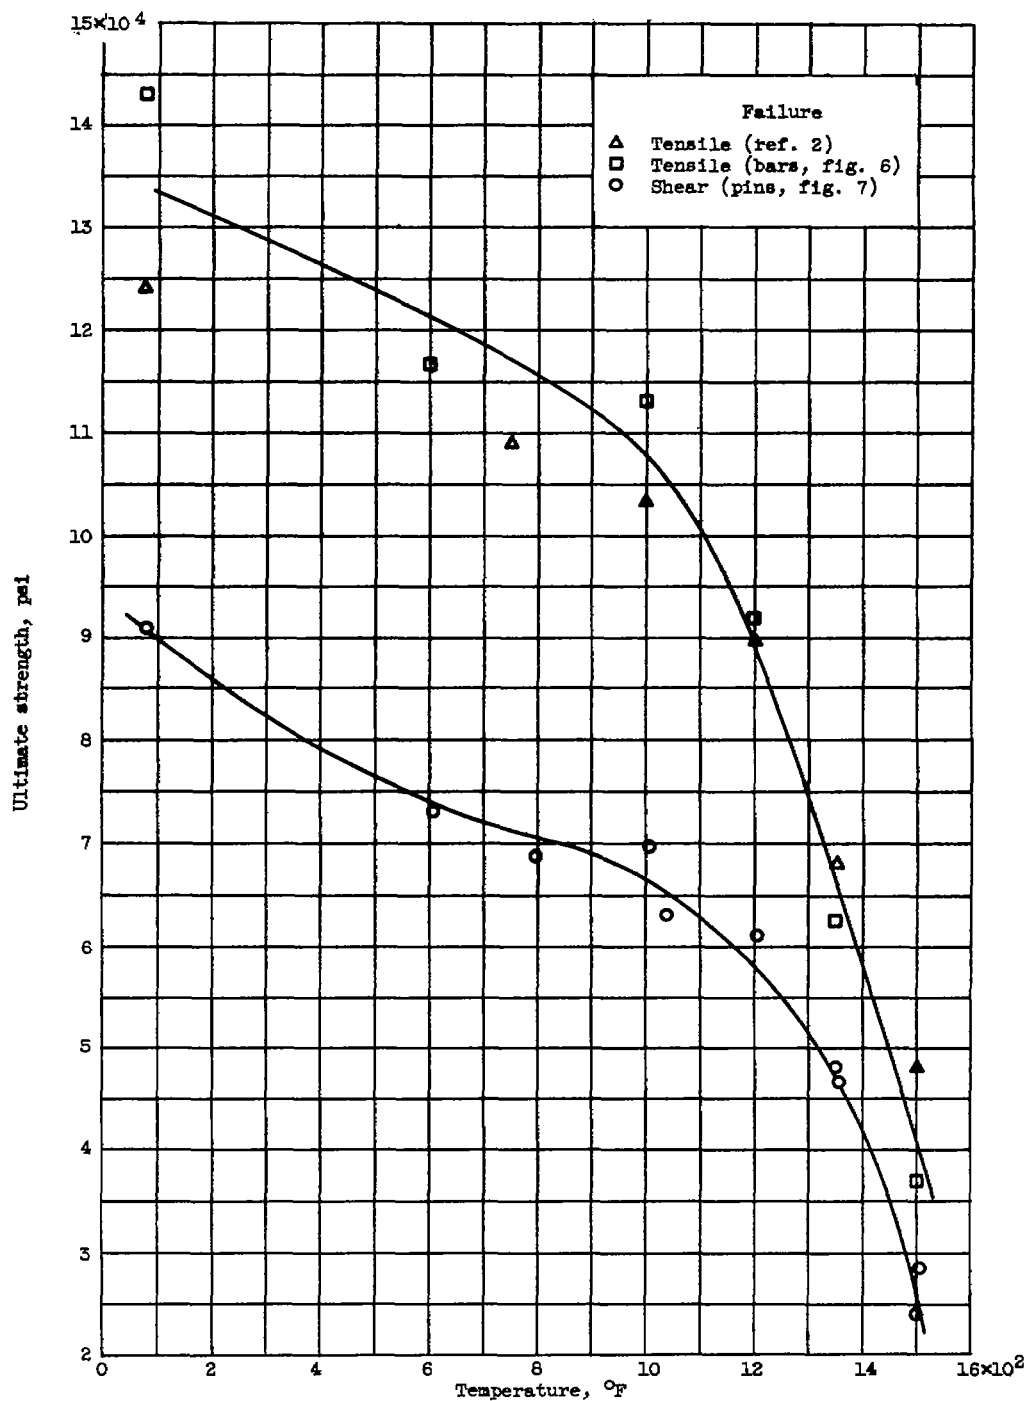
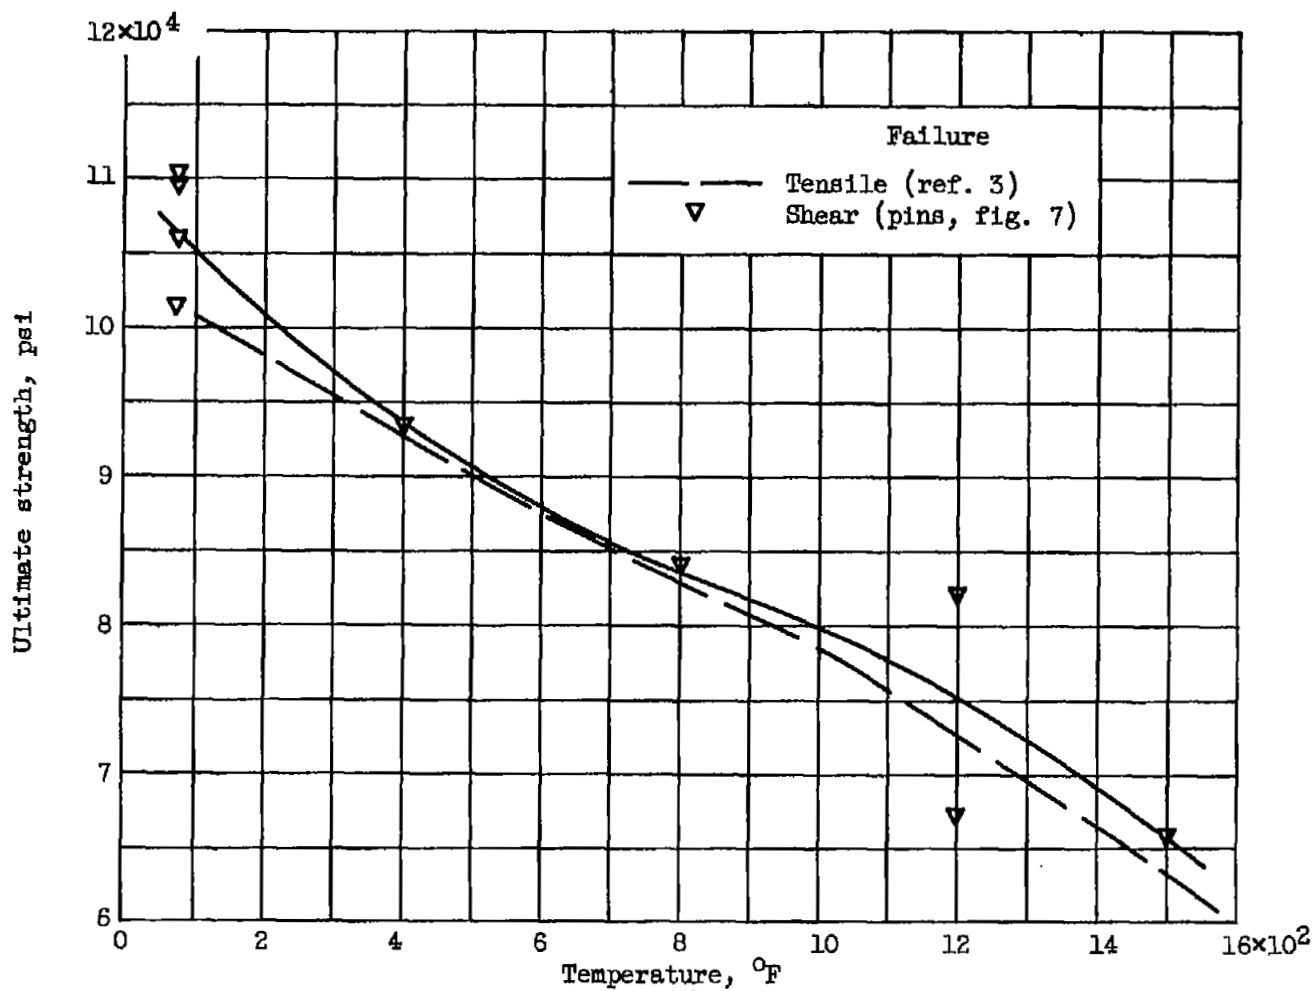
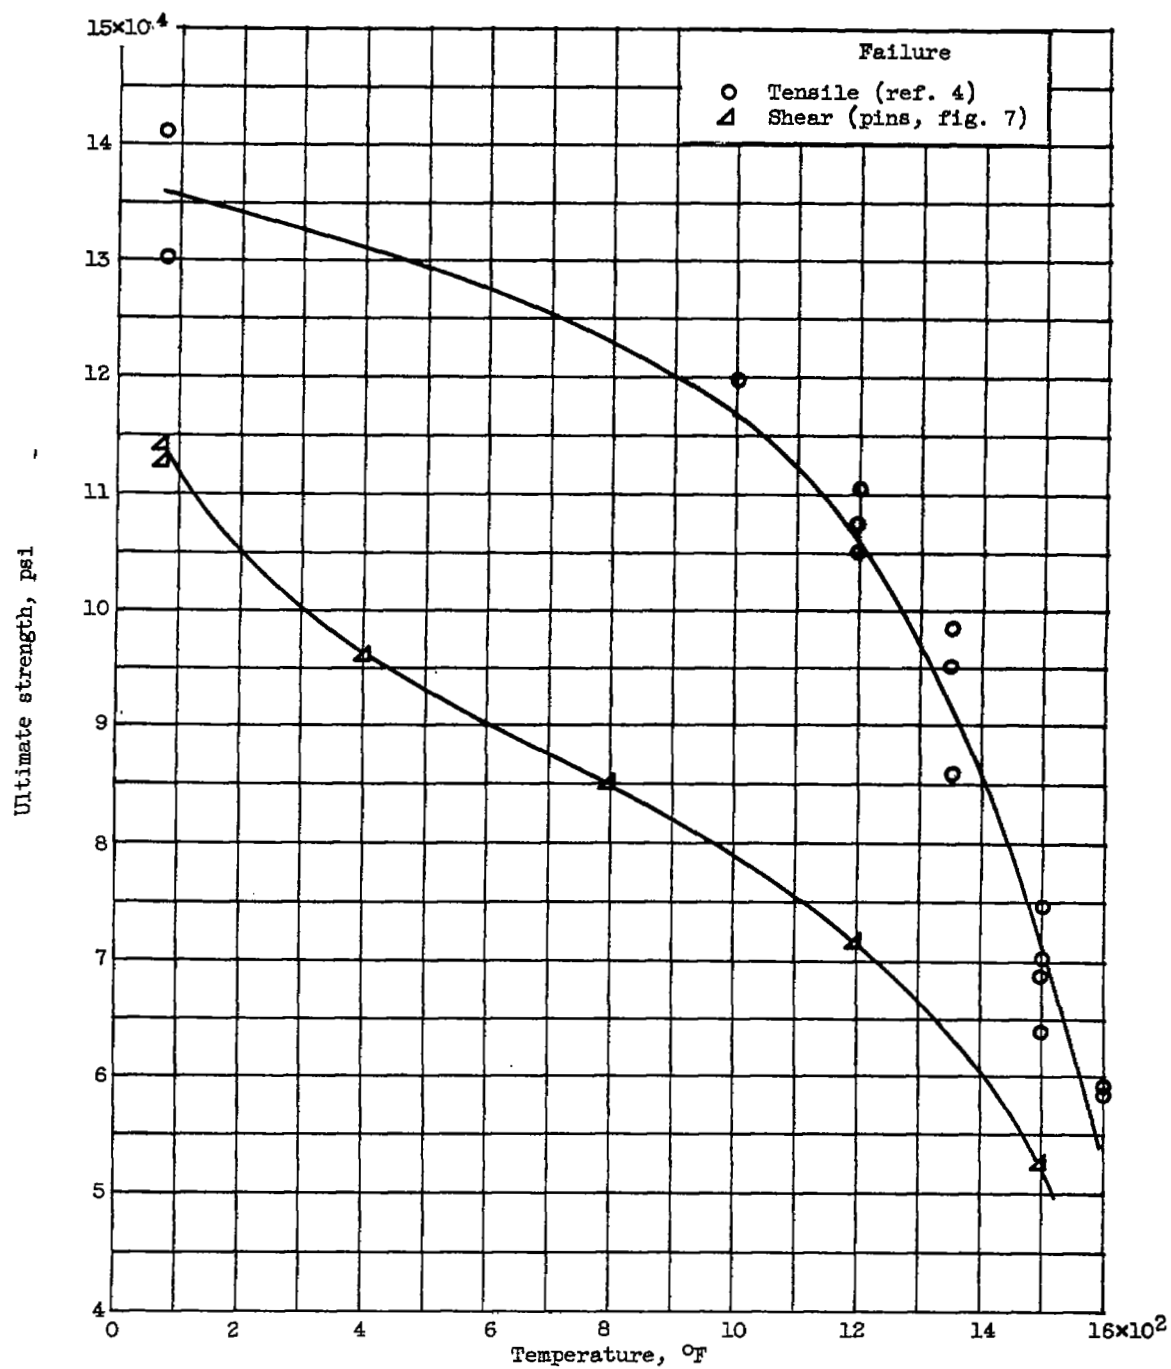
(a) Timken 16-25-6.

Figure 11. - Short-time tensile and shear properties of turbine blade and rotor materials at various temperatures.

(b) Stellite 21.

(c) S-816.

approximated constant ratio with respect to tensile strength as is the case for many materials at room temperature. The proportion, which varies from 50 to 100 percent, depends on both material and temperature (fig. 11). The rather surprising fact that the shear strength of Stellite 21 appears to be comparable in magnitude to the tensile strength (fig. 11(b)) was repeatedly checked with the same result. This result is probably explained by the relatively coarse grain structure of Stellite 21. Tensile failures are intercrystalline; but shear failures are generally transcrystalline, because the shear areas of the 1/8-inch-diameter pins and of the root serrations, carrying the shearing loads, are small and frequently confined within the grain. Evidently, the individual crystals or grains have shear strengths equal to the tensile strengths of the grain boundary material.

High-temperature alloy S-816 was also checked for shear strength (fig. 11(c)) and found to have very nearly the same short-time shear strength as Stellite 21. Thus, if the failure mechanism of a root is shear of the blade teeth, the results with S-816 should approximate those found with Stellite 21. If the failure occurs in tension of the blade root, an S-816 specimen would demonstrate higher strength than a Stellite 21 specimen.

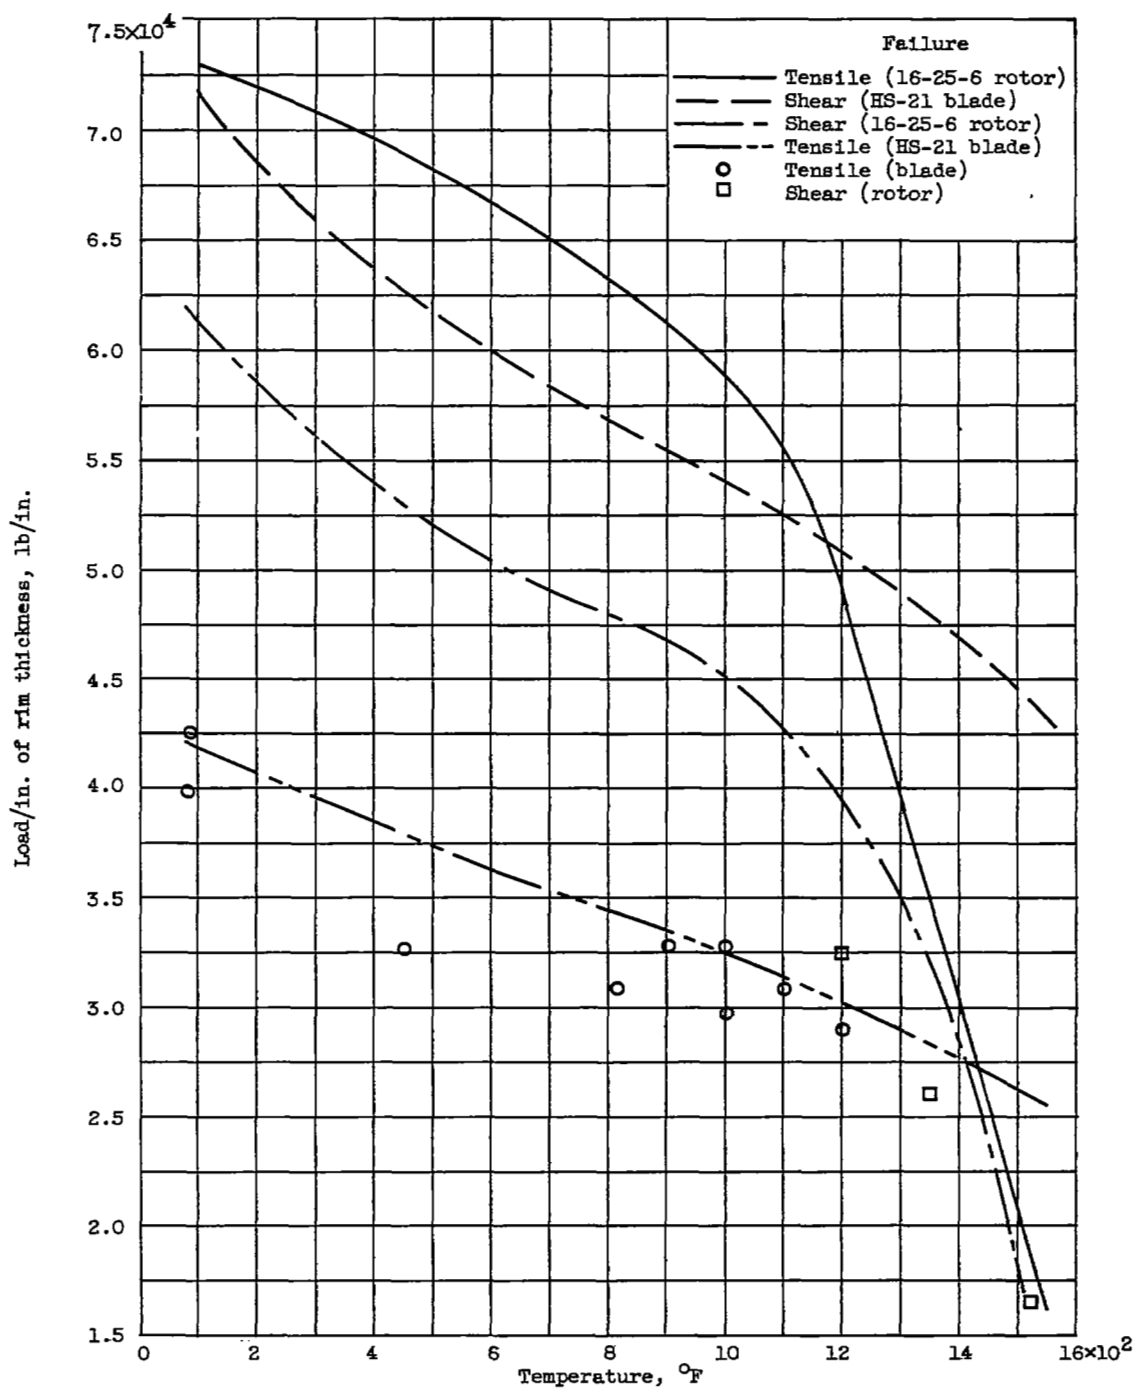
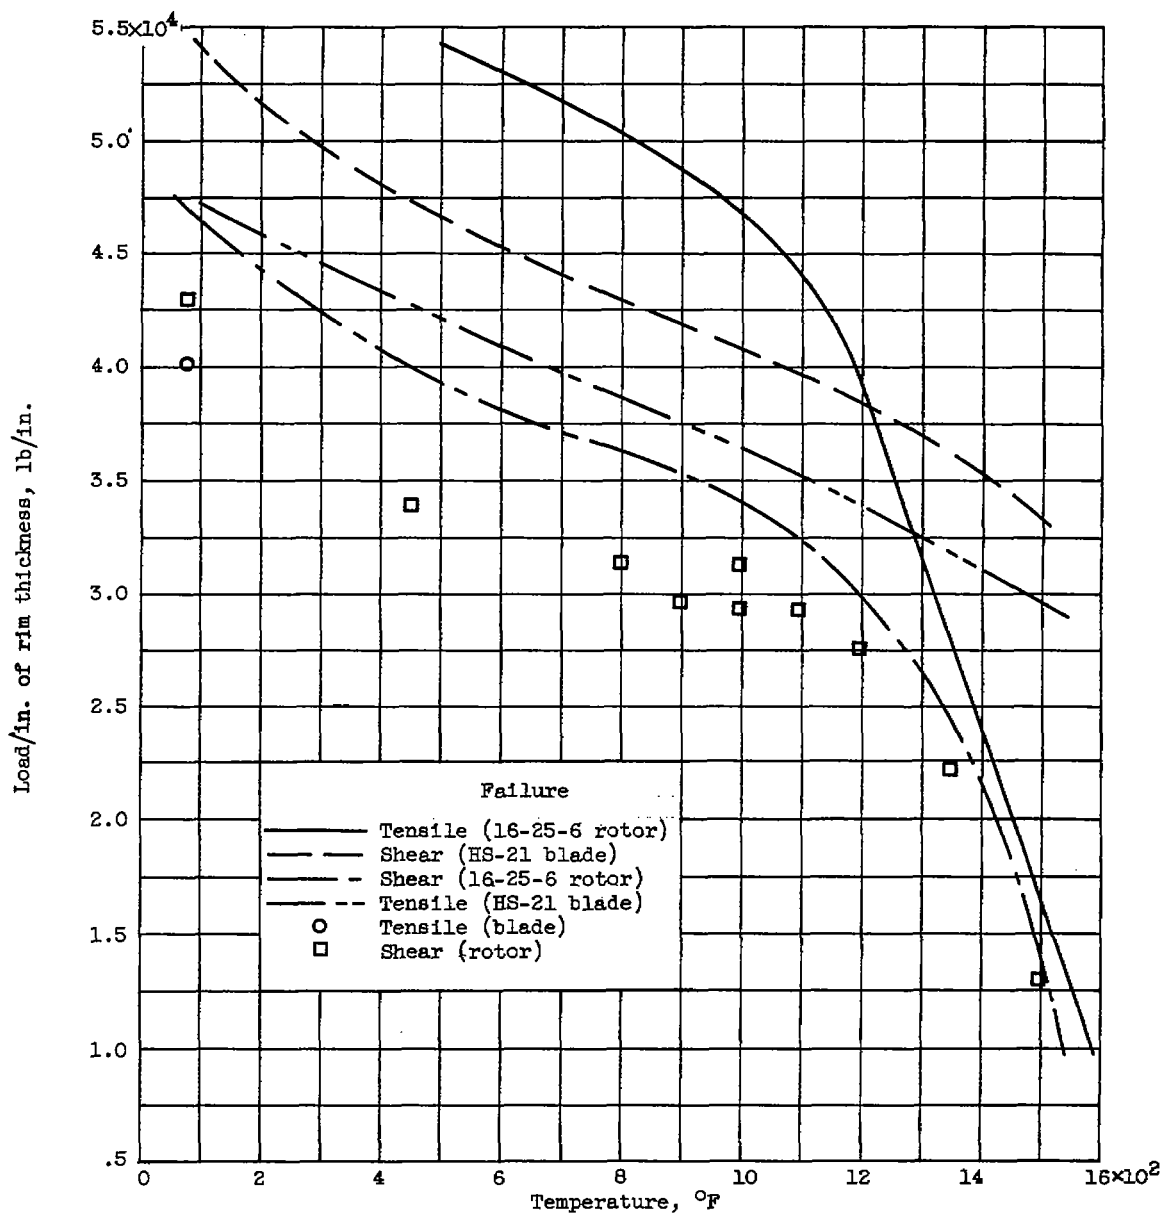
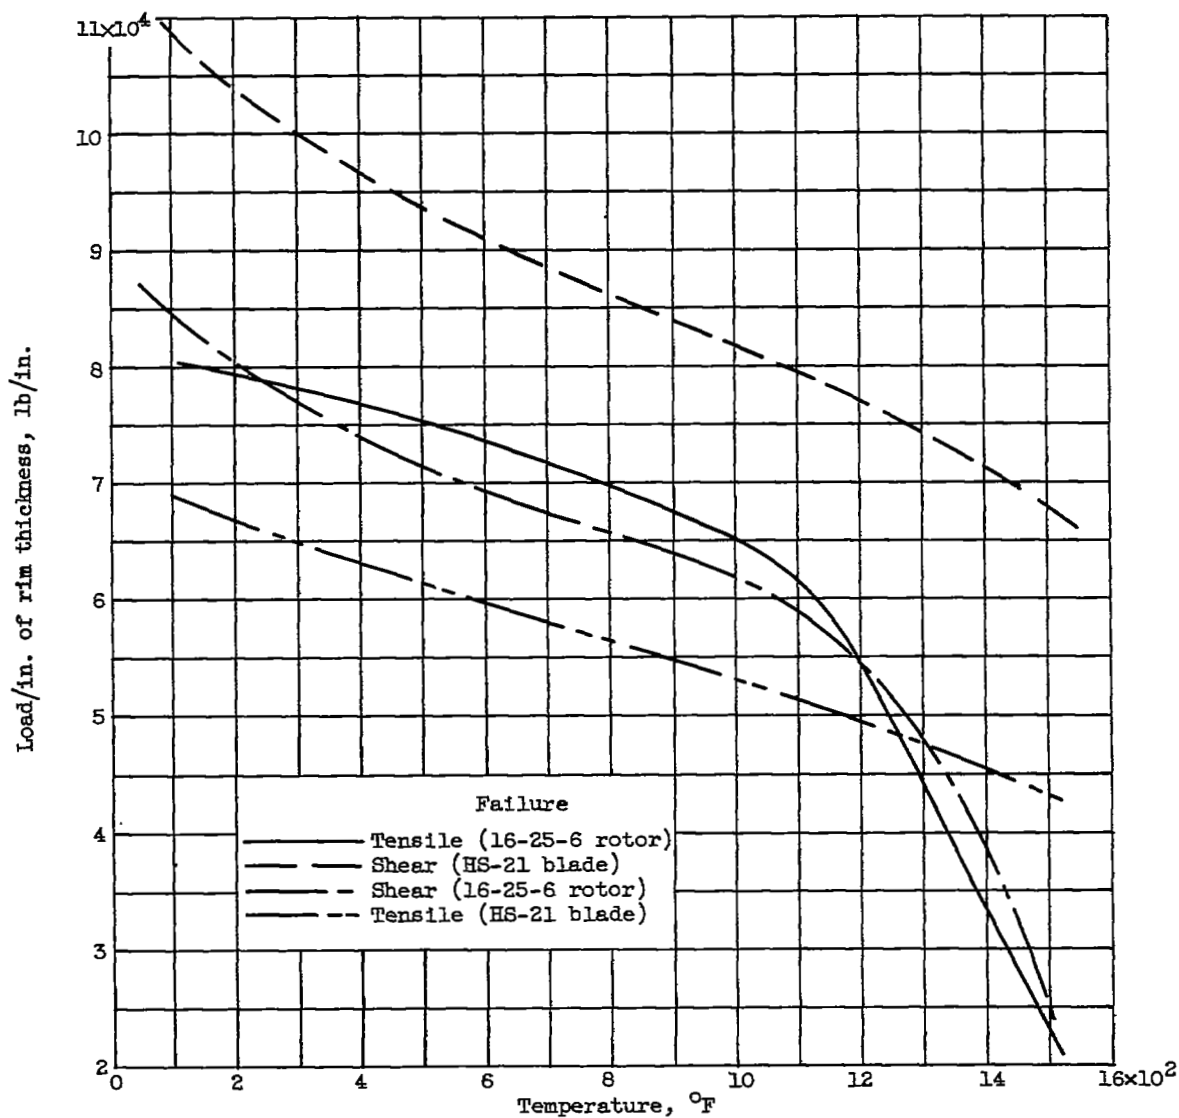
(a) Blade root A.

Figure 12. - Mechanism of short-time failure as result of variations in temperature.

(b) Blade root B.

(c) Blade root C.

The data presented in figure 11 for tension and shear of the blade and rotor materials are converted to load per inch rim thickness for all three root configurations in figure 12. The reason for the shift in failure mechanisms is readily apparent in this figure. For blade A (fig. 12(a)), the strength is lowest across the tensile area of the blade root below 1400° F. Above 1000° F the shear strength of the rotor material drops more rapidly than the tensile strength of the blade as the temperature is increased; and, consequently, above 1400° F the strength is lowest at the shear area of the serrations in the turbine rotor. In tensile tests of root specimens, the transition in failure mechanism took place at 1200° rather than 1400° F. The reason for this discrepancy between experimentally determined material properties and root specimens is not known. Figure 12(b) shows the lowest strength existing in shear of the rotor segments throughout the entire temperature range. The proximity of the tensile strength in the blade to the rotor shear strength at room temperature accounts for the tensile failure at room temperature. As in

figure 12(a), shear strengths of the specimens in figure 12(b) are again slightly below the shear strength of the material. At first examination, it might be concluded that the assumed shear area is in error, but the excellent correlation between the long-time specimen strength and material shear strength based on the same assumed areas indicates that some other factor is responsible for lower shear strengths in the root than predicted by material data. This discrepancy may be caused by the lack of perfect matching between wheel and blade root teeth due to machining tolerances. At the higher temperatures, some plastic flow and creep take place, which load the teeth equally and possibly account for the better correlation between specimen and material properties above 1100° F and in the long-time tests.

Although short-time tests on the root of blade C were not actually conducted, converting the material properties of figure 11 indicates that a shift in type of failure can also be expected here (fig. 12(c)). Below 1250° F the fastening should fail in tension of the blade root; above 1250° F tensile failures of the rotor segments generally are to be expected.
